Prehistoric Sites – Risser Ranch Ruin

CONTRIBUTOR: Jim Britton - AAS Phoenix Chapter

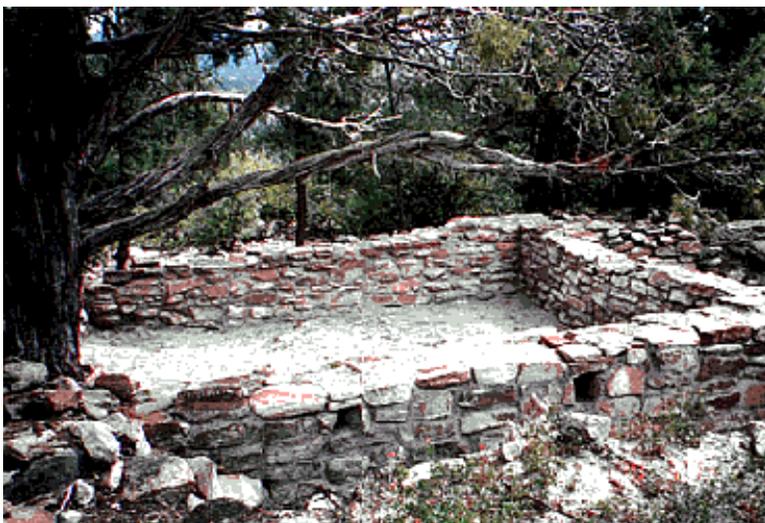
Room 8 looking south east. Vent holes as seen from Rm 7.

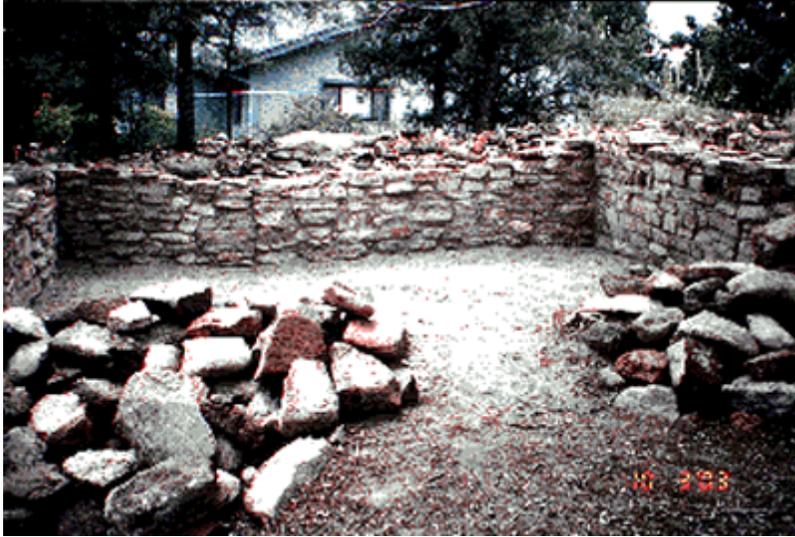
Room 8 looking south. Stones in foreground are north wall fall.

This wall has a vertical mortar joint located 2.02 m west of the SE corner. Viewed from the Room 12 side some people have suggested it is a door way. However, viewed from the Room 8 side there is definitely only one vertical mortar joint. If it had been a door, the east side of the door must have collapsed. Another possibility is that the builders may have constructed a wall and then extended it further to the east.

A 4 m section of the Room 8 wall face required from two to four courses to be realigned. Keep in mind that these walls are two stones wide. The opposite side of this wall (Room 12 wall face) was missing two to four courses of stones and needed to be reconstructed in order to match the height of the Room 8 face. Both wall faces were repointed, i.e. all mortar joints were cleared of loose mortar and filled with new amended mud.

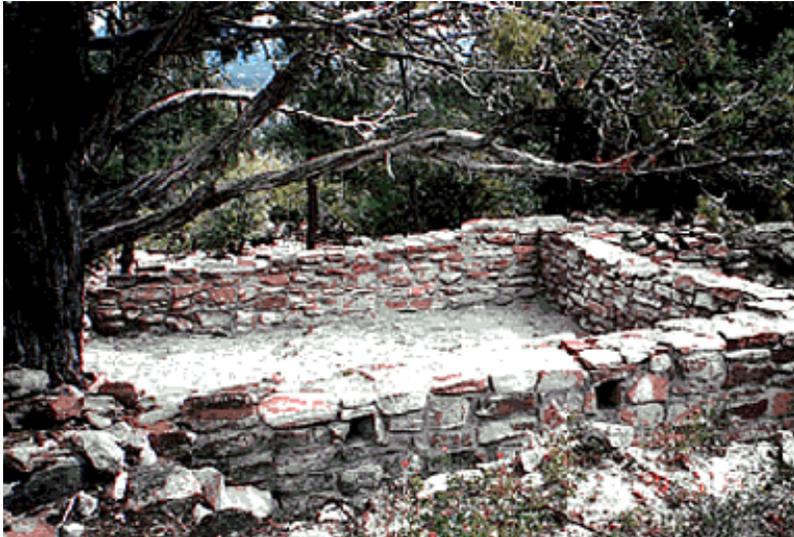
Completed Room 8 west wall. Note 3 vent holes

A section of this wall, 2.5 m in length, is leaning into the room. After completion of the excavation in 1990, backfill had been thrown into this room and most likely saved this wall from collapse. J. Britton decided to push this leaning section back vertical before stabilizing it. On April 26, 2002, he documented the wall by taking photos and measurements. The next day Britton along with B. Wright and C. Knutson constructed a push board using a 4 ft by 8 ft sheet of heavy plywood and various pieces of lumber. Two jacks were used to apply force to the push board. When the wall reached a vertical position, 2 x 4s were to be placed as braces and then the jacks would be removed. As the first 2 x 4 was being put into position something caused a jack to fail. This caused the interior face of the wall to burst in toward the room. The result was a pile of rubble leaning against the push board.

J. Britton decided, after thinking about the options, to challenge himself to relay the wall, putting each stone back into its original position. He used computer scanned photos to make several 8.5 by 11 inch “wall maps”. The exterior wall face remained standing, but all mortar joints were loosened by the traumatic force of the “exploding” wall. A small number was written on the face of 36 stones as well as on the “map”. This side of the wall was then dismantled and relayed using the photo “map” as a guide.

Using the enlarged photos, Britton identified and numbered each stone of the interior wall face as they were removed from the rubble pile. There were 73 stones on the interior wall face that were relayed using amended mortar. Only one relatively small face stone was never found. A reconstructed cap of one to two stones high was laid on the wall top to make all three vent holes complete and to seal the wall top against the harsh winter weather conditions. When completed this wall was nine to ten courses high.
