Arizona Archaeological Society Prehistoric Sites -- Q Ranch Pueblo

CONTRIBUTOR: Jim Britton (Phoenix Chapter AAS)

The stabilization information discussed below was taken from the field notes of Jack Bashaw and Jim Britton.

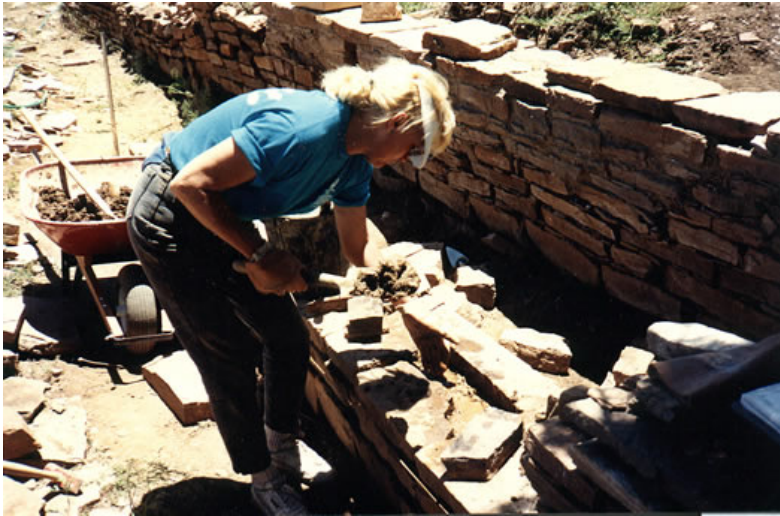
Marie reconstructing a course on the east wall of the entry way into Room 15. The wall behind is the 1990 stabilization project done by J. Britton and J. Bashaw.

1991 Week 1-Stabilization and Restoration was again offered as one of the field school classes. M. Reid (Britton) signed up for the first week. She was assisted by J. Britton and J. Bashaw. The objective was to reconstruct a portion of the east “entry way” wall that leads to Room 15. When original stones are missing reconstruction is necessary. Therefore, replacement stones had to be retrieved from piles located in the plaza. The mortar formula used was 4 parts soil to 1 part cement. Finding a good color match became a big problem. We never were real successful.

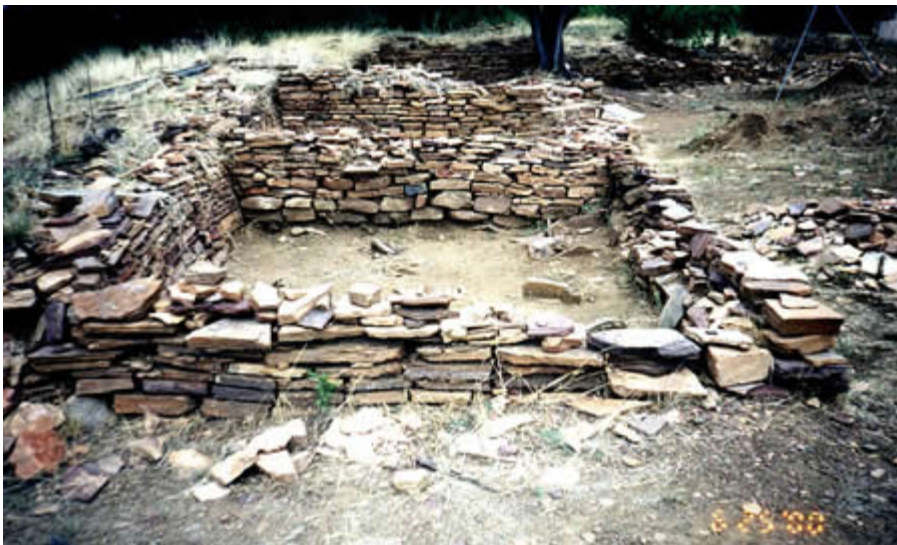
Pueblo I, Rooms 3 and 4 looking North before being stabilized. Photo taken June 2000.

2003 J. Britton supervised the stabilization crew which included: M. Britton (2 days), D. Sorensen (5 days), W. Sorensen (5 days), and G. Kurzhals (3 days). Our first objective was to repoint the west wall of Room 3 and to relay and repoint the east walls of Room 3 and Room 4 in Pueblo I. The east walls of these two rooms were in very bad condition due to being exposed to weather, animals, and differential fill for approximately 12 years. Using enlarged photos as maps, the stones were numbered and marked on the map. The stones were then removed, new amended mortar applied and the stones relayed. Where needed new stones were added to even off a course. SoilShield-LS was used again this year at a ratio of 20 to 1 to make the amended mud.

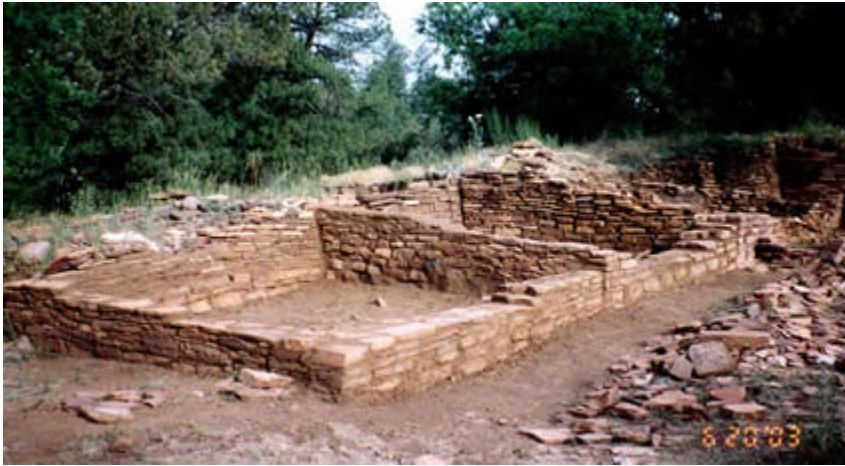
Pueblo I, Rooms 3 and 4 looking North West after stabilization. Photo taken June 2003.

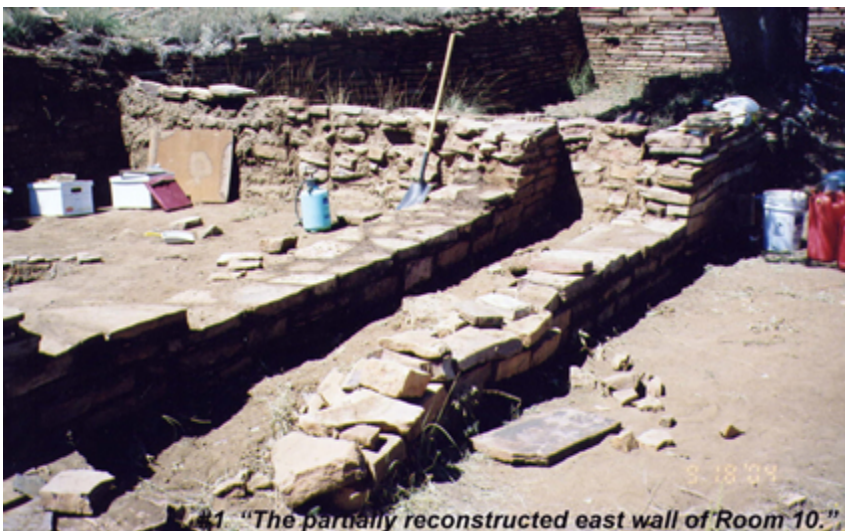
2004 Stabilization work was scheduled to be done during the September Work Weekend that ran from the 16th to the 20th. Our main objective this field session was to reconstruct and stabilize the east wall of Room 10 (On 1989 site map this room was shown as Rooms 9 and 10). The center portion of the wall had collapsed sometime prior to April 2003. The stones fell to the east and landed in a pile of rubble. Prior to the June 2003 field session, the stones were removed to facilitate a mapping session lead by John Hohmann. Since the stones had been removed there wasn’t anyway to identify them and relay them in their original positions. Therefore, we reconstructed the bottom three courses along the collapsed section and stair-stepped it up to meet the still intact sections next to the north and south walls (See photo #1). J. Britton lead a crew composed of W. Lesko, M. Britton, S. Lesko and D. Bengé.

#1 "The partially reconstructed east wall of Room 10."

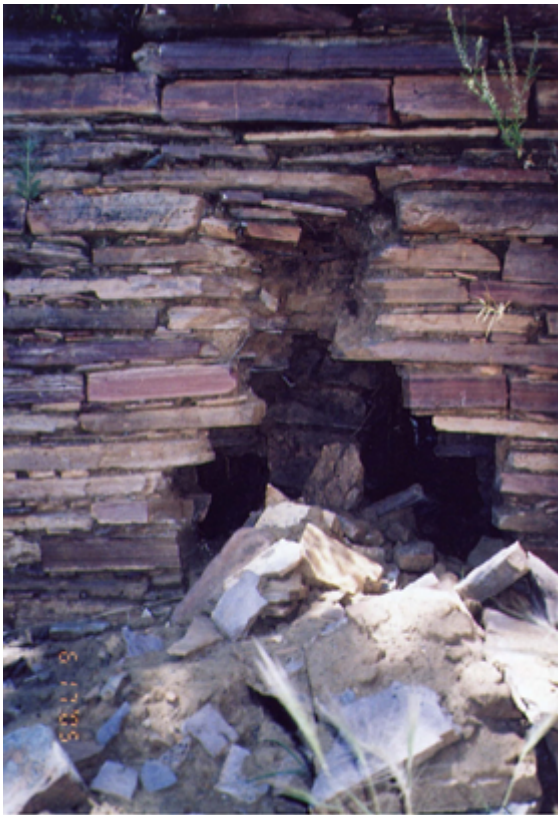
#2 "Vandal damage to the north wall of Room 15.

Room 15 north wall had two rather large holes and the west wall had one small hole. The vandal had removed wall stones and excavated fill dirt from the rooms behind the wall. The removed stones and fill dirt were piled at the wall base (See photo #2).

The damage shown in this photo took place where there was a unique wall feature. Prehistorically this feature had been formed by chipping a hole in the wall and then filling it with rather small flat stones. By using old photos we were able to identify the original position of each stone. The crew included Walt Lesko, Sylvia Lesko, Larry Roberts, Jerry Mead, Jim and Marie Britton.

We used unamended mud to replace the room fill. However, we used SoilShield amended mud to relay the wall stones in there original positions (See photo #3)

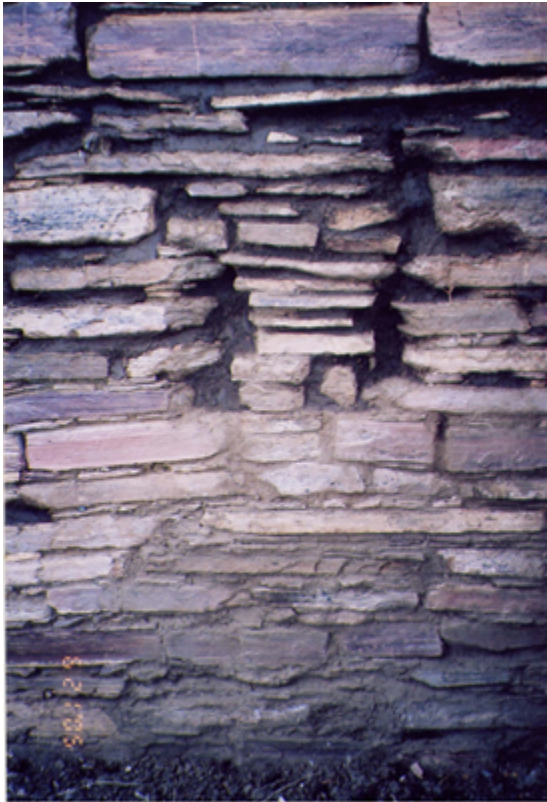
#3 " Relayed wall face of damaged area shown in photo #2."

The SoilShield solution used to make the mud was a ratio of 20 parts water to 1 part SoilShield.

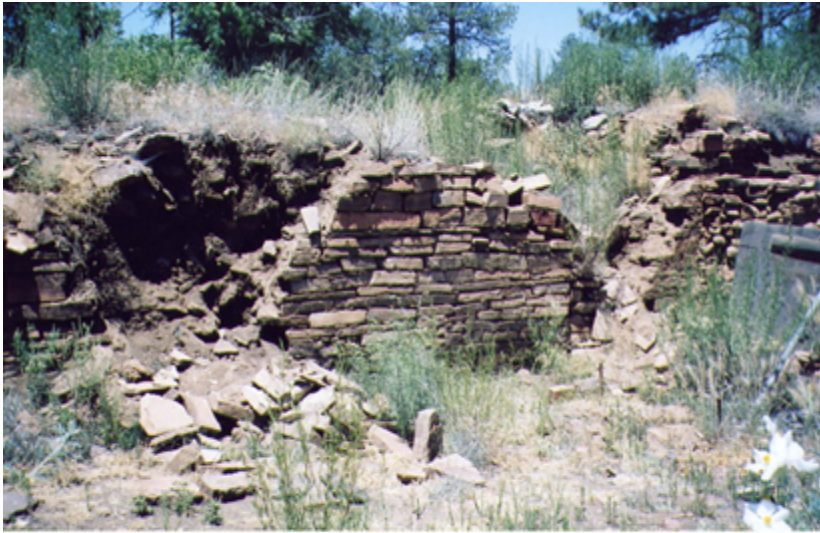
Other damage blamed on the vandal included two partially collapsed wall sections along the west side of the plaza . These sections involved the east walls of Rooms 37 and 38 (See photo #4). The hole in the east wall of Room 37 ranged in width from 1.26m to 2.3m at the top.

#4 "Damaged wall along west side of Pueblo I plaza. Room 37 damage on the left, Room 38 on the right."

The hole in the east wall of Room 38 ranged in width from 48cm to 1.56m at the top. Larry Roberts reconstructed the missing courses in this section. We used unamended mud to reconstruct both collapsed wall sections. There is a plan to backfill to buttress this wall in the future. With that in mind, and the fact that these walls will not be exposed to weather, it was decided not to use the rather expensive SoilShield amendment.

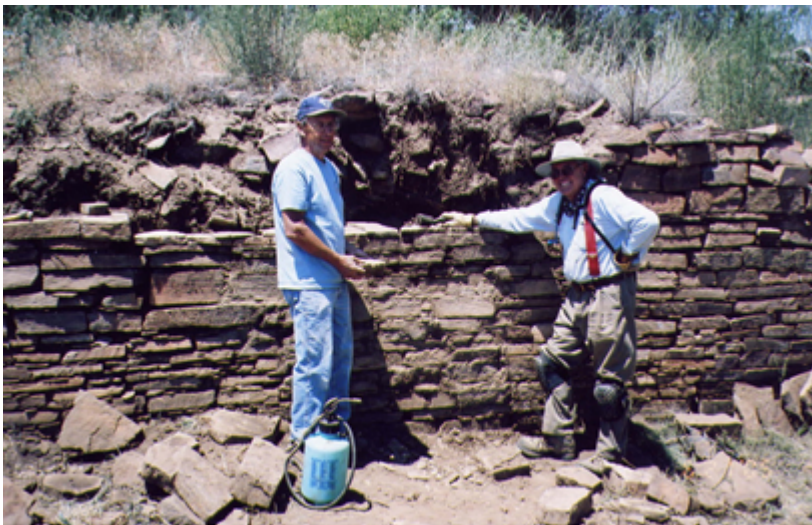
#5 "Walt and Jerry reconstructing the wall of Room 37." □

Jerry and Walt reconstructed the missing courses using stones that matched the height of the existing stones that had remained in place during the collapse (See photo#5).
