Arizona Archaeological Society Historic Sites -- SWANSEA

STABILIZATION HISTORY AT SWANSEA:

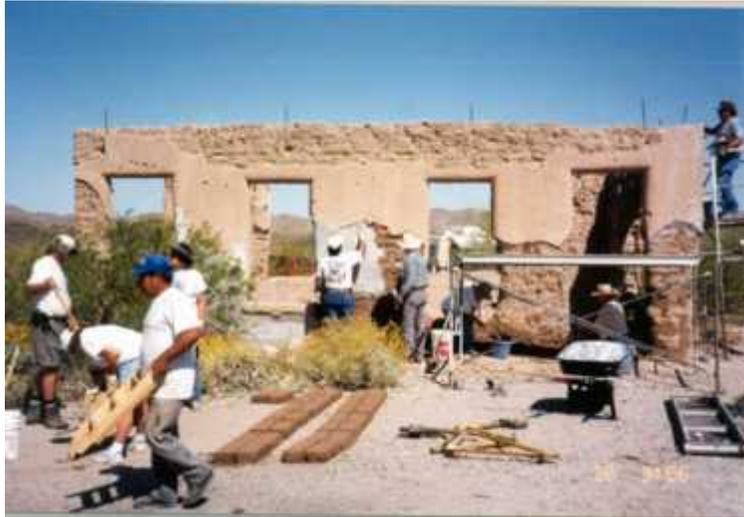
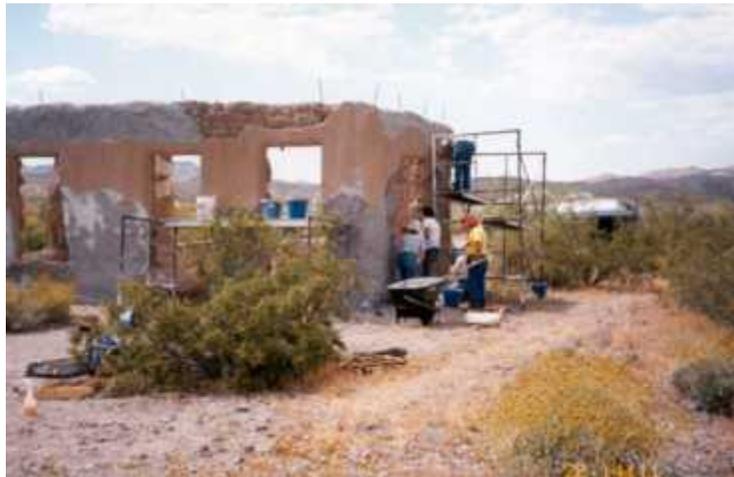
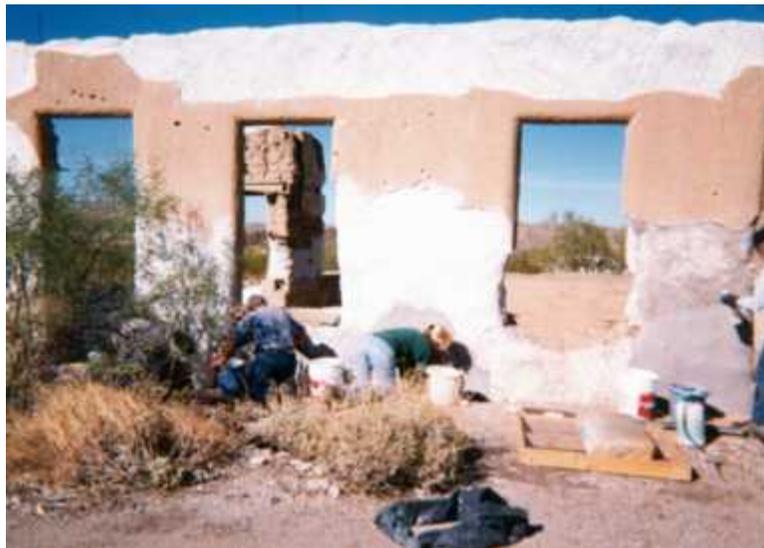
The following photos represent stabilization of the train depot which included the application of lime plaster.

The third workshop in March 2000 was funded by BLM and the Friends of Swansea. Perhaps scheduling in March was not such a good idea because there was only two BLM volunteers who participated in the plastering. BLM masons provided the additional assistance needed to almost complete the railroad depot's final coat of plaster, applied a scratch coat of plaster to a section that had not been plastered, and finished the final plaster coat with a native soil stain.
