Arizona Archaeological Society Prehistoric Sites -- Q Ranch Pueblo

CONTRIBUTOR: Jim Britton (Phoenix Chapter AAS)

The stabilization information discussed below was taken from the field notes of Jack Bashaw and Jim Britton.

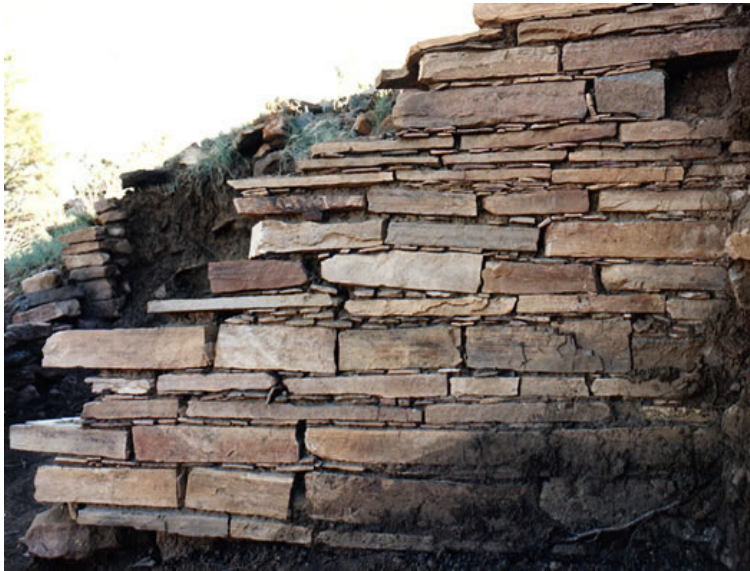
Good example of a full coursed exterior wall face with it's flat tabular sandstone and small chinking stones in the mortar joints.
